Report No. CG-D-08-00

EVALUATION OF WINDOW FAILURE MODES

**FINAL REPORT
DECEMBER 1999**

**U.S. Department of Transportation
United States Coast Guard
Marine Safety and Environmental Protection (G-M)
Washington, DC 20593-0001**

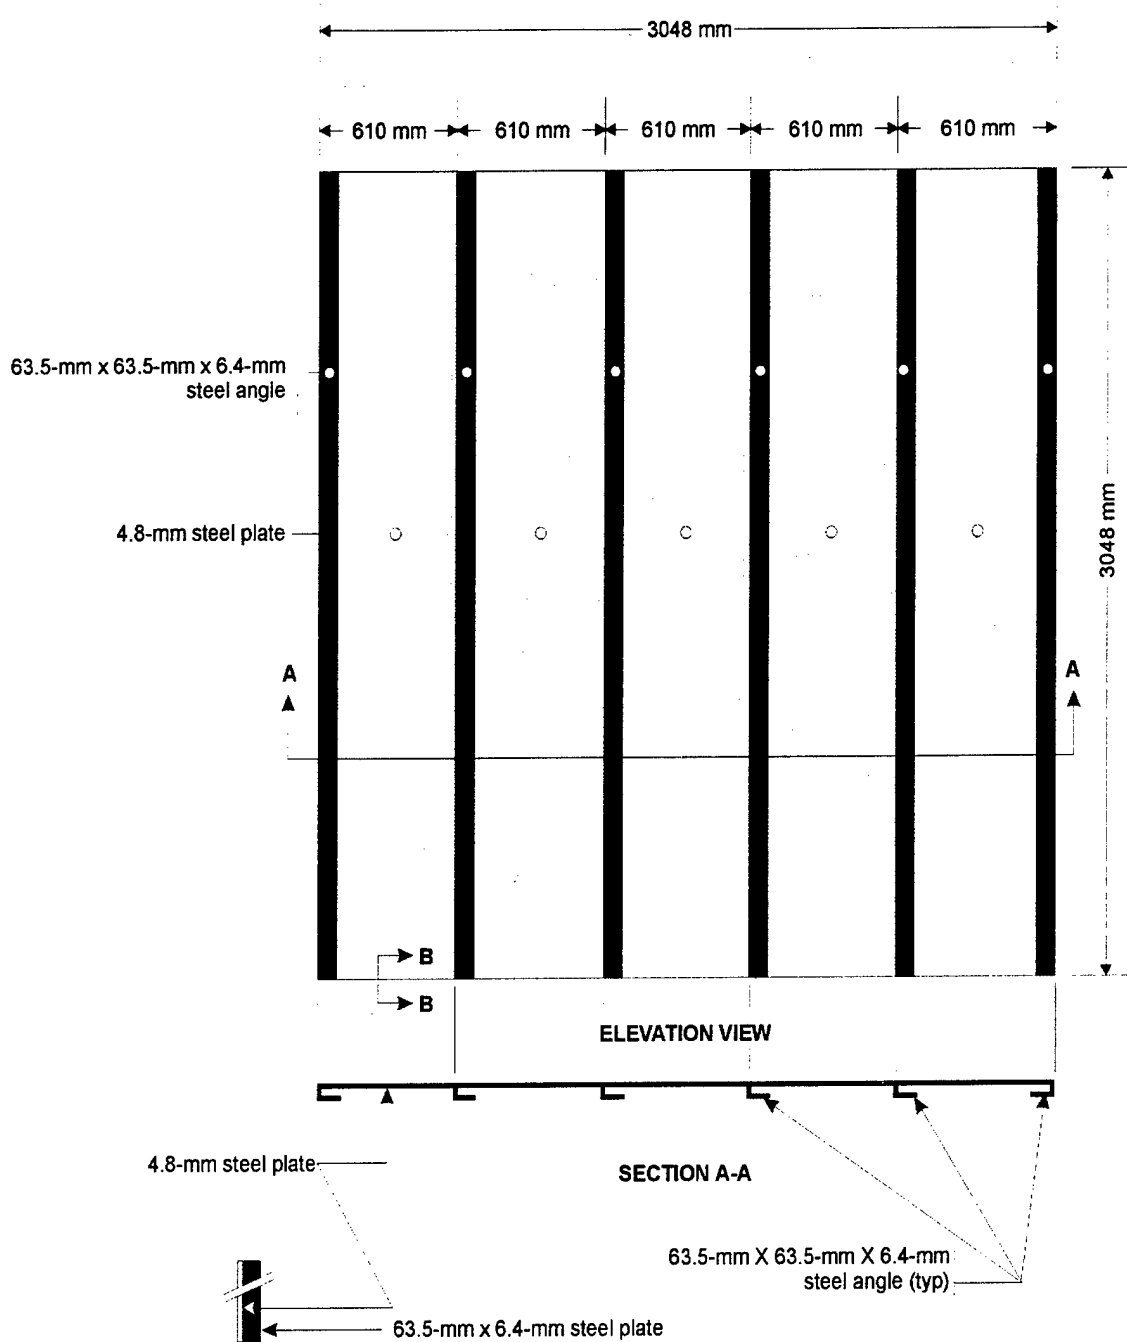
Figure 1. Bulkhead construction.

The steel bulkhead consisted of 4.8-mm steel plate, continuously welded on one side, reinforced with 63.5-mm x 63.5-mm x 6.4-mm steel angle stiffeners, positioned 610-mm o.c. as indicated. The top and bottom were reinforced with 63.5-mm x 6.4-mm steel plate as shown.
